AA-1044
Mt. Zion United Methodist Church
Pasadena
Private

State Historic Sites Inventory Form

Survey No. AA-1044

and/or common Mt. Zion United Methodist Church

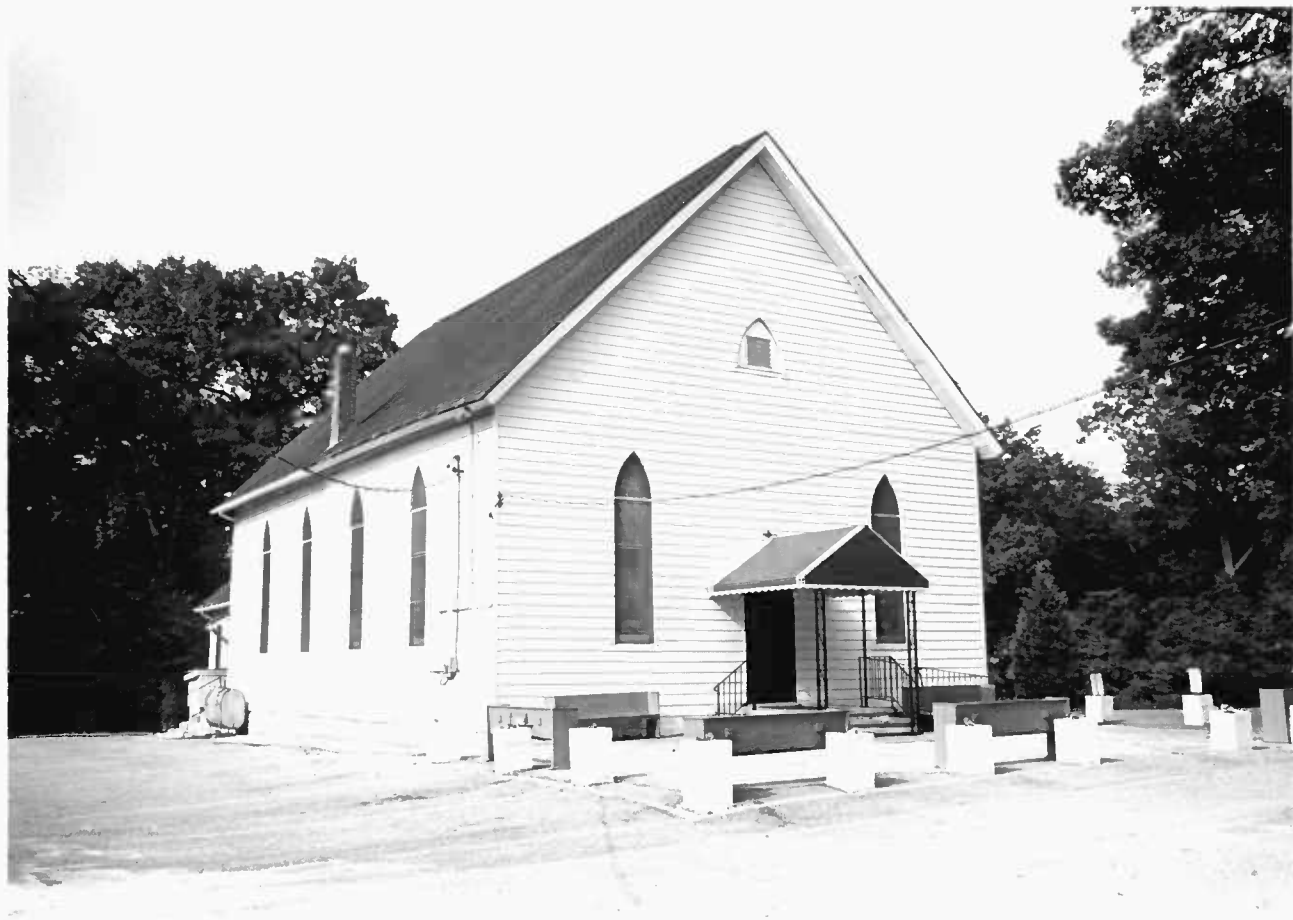
1 of 4

1/4 EAST PERSPECTIVE

Mt. Zion United Methodist Church faces north and is flanked on its front and east sides by paved parking areas, and on its rear and west sides by mature stands of trees. Mt. Zion, built in 1883, is a simple, gable-front, frame building. It has one extended story, and is built on a rectangular plan. The front facade contains three bays, and the side have four. Walls rest on a rubble field stone foundation. The steeply pitched gable roof is sheathed in asphalt shingles and is pierced on both sides, near the wall axis, by a small, brick, stove chimney. A small, low addition projects from the rear of the building.

Windows are consistent throughout the structure. Tall and narrow, with a pointed-arch top, windows contain opaque and colored glazing. Centered in each is a decoratively glazed circular section displaying a biblical motif, e.g. cross, anchor, etc. Windows are fixed sash, but a hopper section is present in the lower level of each window, which opens for ventilation. The primary entrance is centered on the front facade and is a modern pair of metal and glass doors. This entrance is approached by three, low, concrete stairs, and is protected by a modern metal awning. A gable window located in the front facade is altered and contains a louvered ventilator insert.

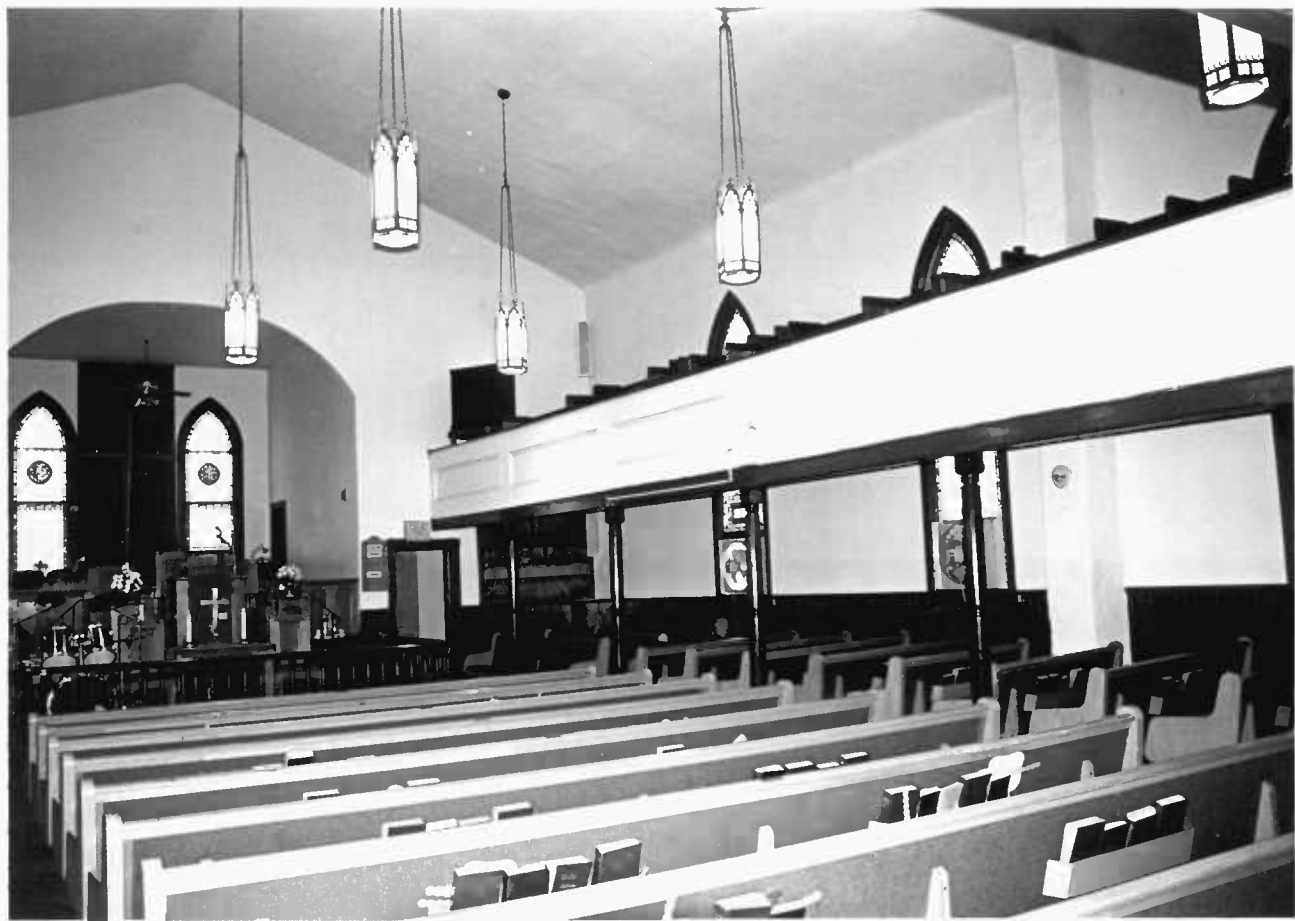
2 OF 4

INTERIOR VIEW

The historic integrity of the church's exterior is compromised by the rear addition and installation of modern exterior treatments, but the building's interior is highly intact and retains most of its original finish, which features plastered walls accented with darkly stained wainscot and window surrounds. Paneled balconies are present on the north and east walls and are supported below by turned posts. Historically, these are very similar in style to the turned balusters of the communion rail. Six octagonal metal lamps are suspended from the ceiling. These are executed in the Gothic Revival style, with metal work design to mimic window traceries.

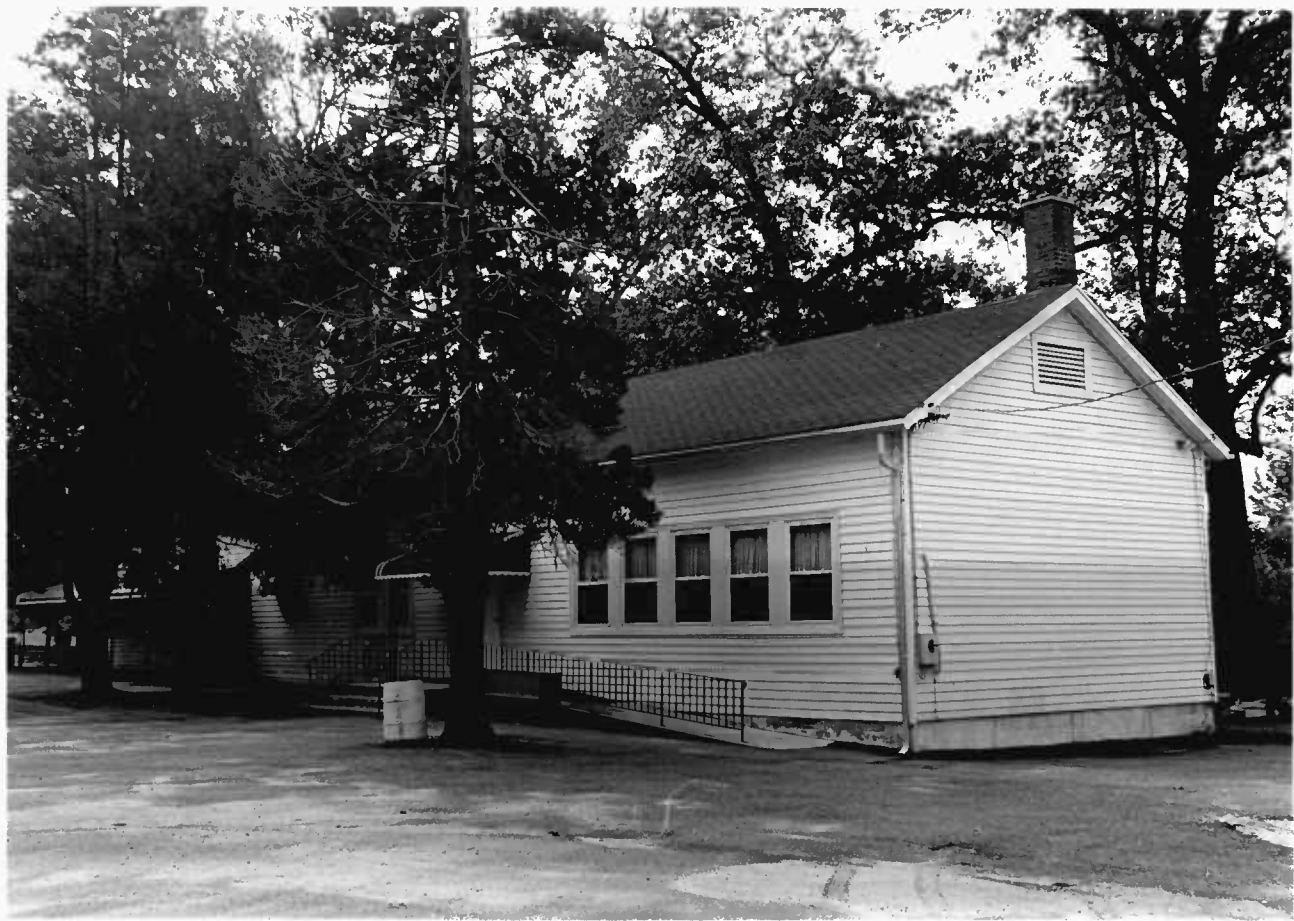
PHOTO 3 of 4

MT. ZION UNITED METHODIST CHURCH SCHOOL
(ROSENWALD SCHOOL)

NE PERSPECTIVE

A former African-American Rosenwald school building, is situated on the property and is located directly east of the church. This long, one-story, gable-roof, frame building was constructed between 1917 and 1932, but its historic character is compromised by the presence of aluminum siding and modern windows and doors. The building's interior is completely devoid of historic finish.

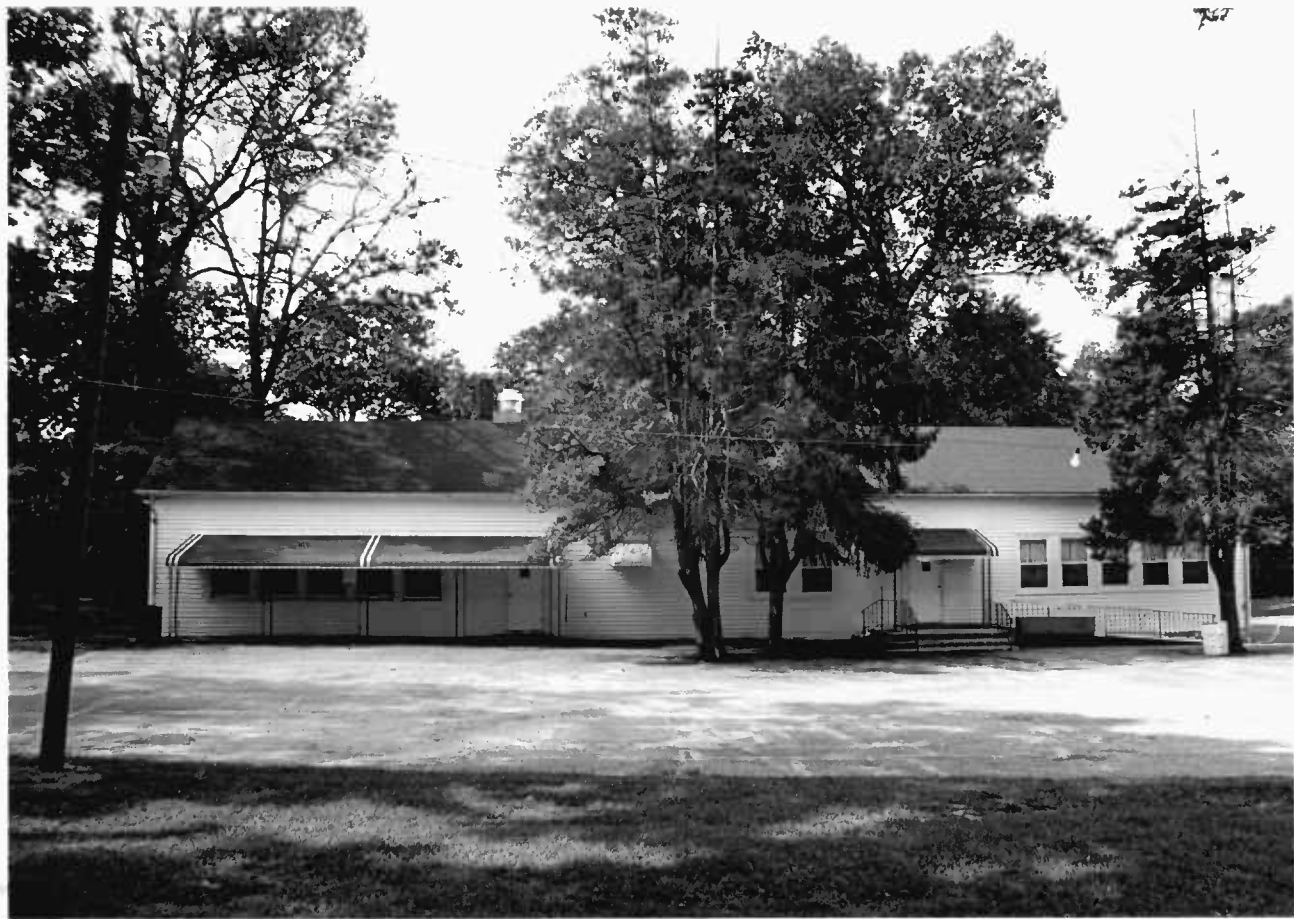
PHOTO 4 OF 4

MT. ZION UNITED METHODIST CHURCH School
(Rosenwald School)

NO ELEVATION
